Phase I Environmental Site Assessment

Blue Lake Business Park

Blue Lake, Humboldt County, California

June 2011
011003.401

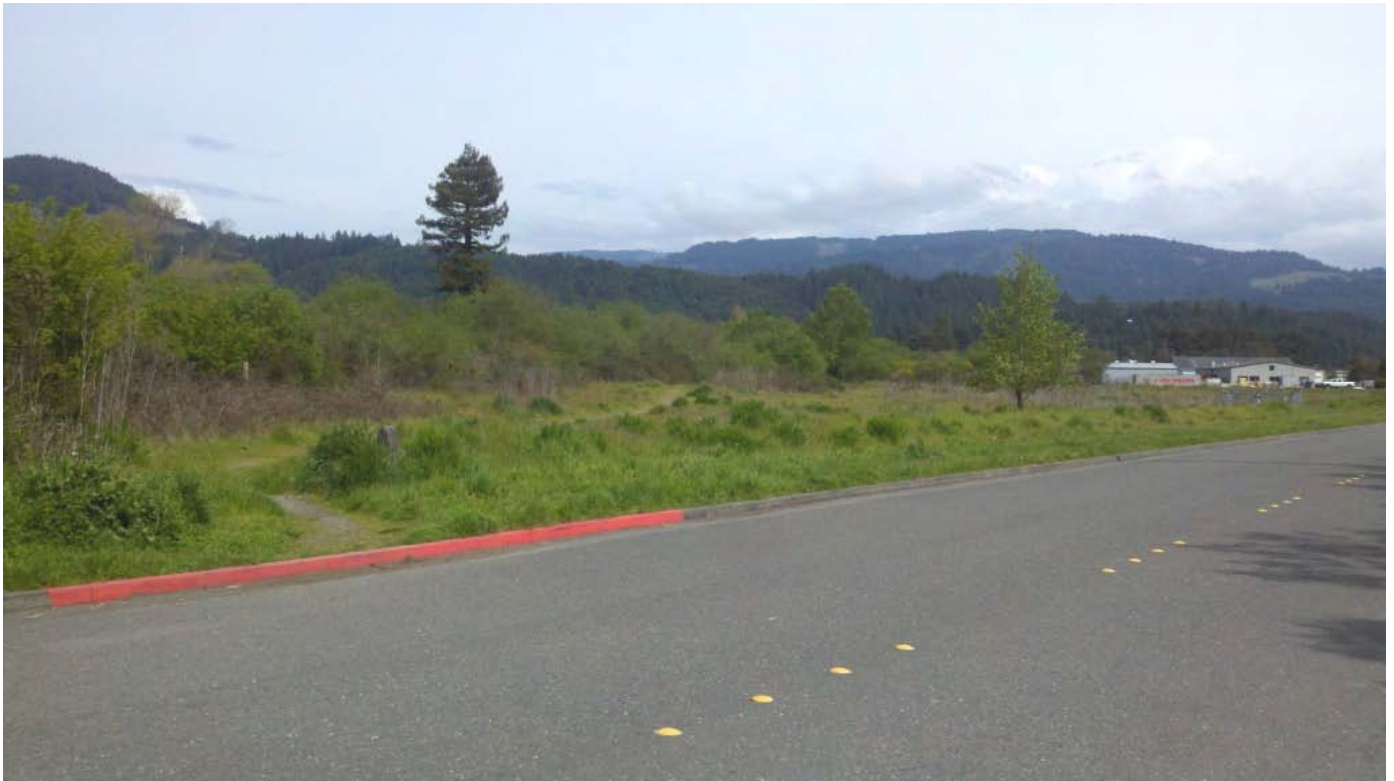
Photograph No. 1: Photo taken looking northeast from Taylor Way, at City parcels (APN 312-161-015 and -018).

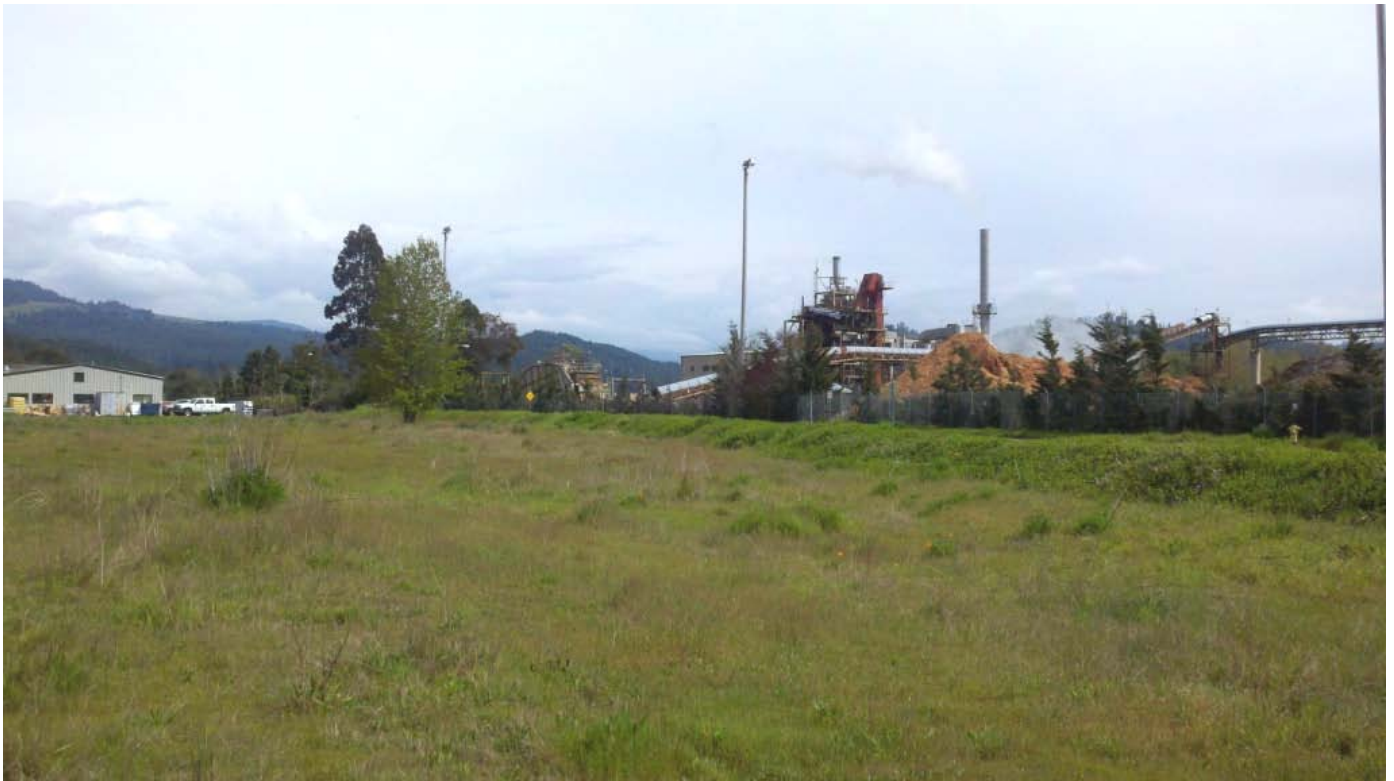
Photograph No. 2: Photo taken from the City-owned parcel (APN 312-161-018), looking southwest at the City-owned parcel (APN 312-161-015). Taylor Way and Blue Lake Power are on the right.

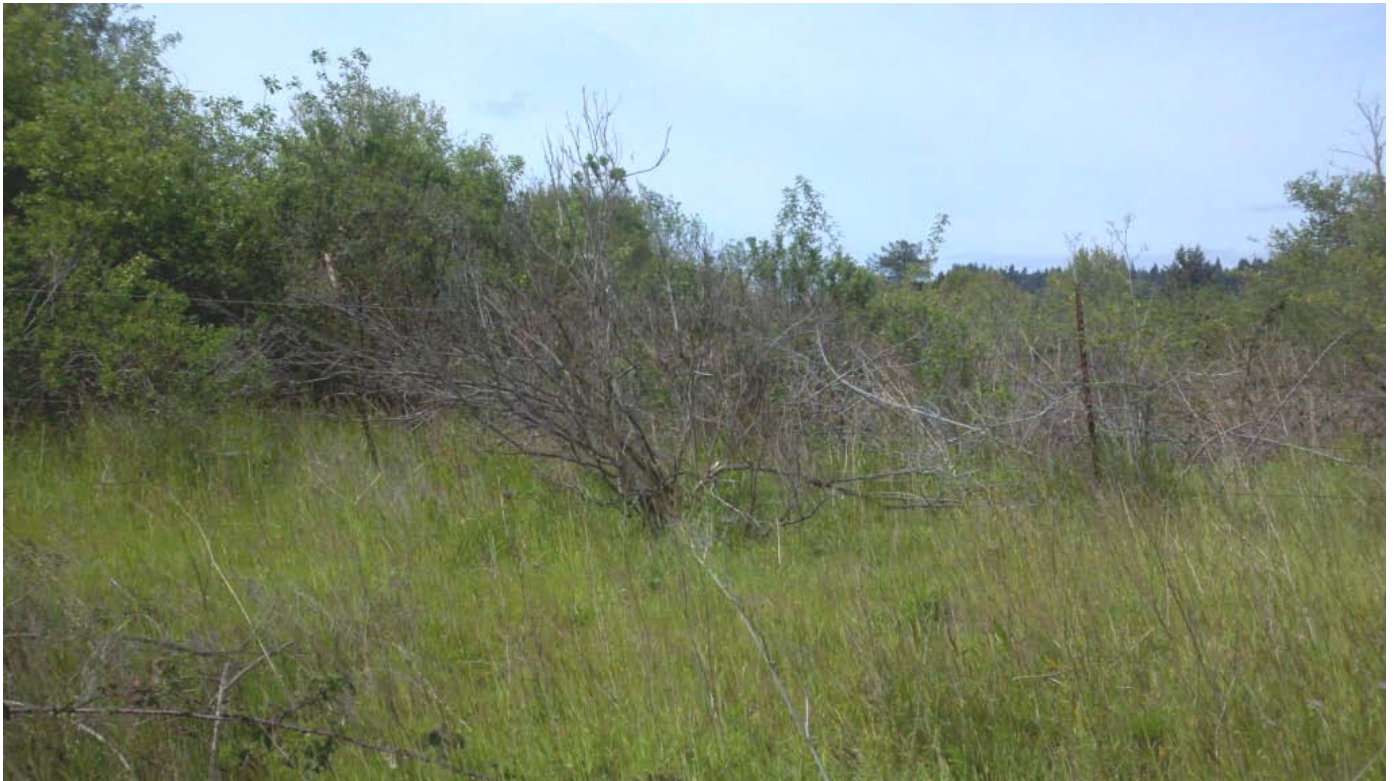
Photograph No. 3: Photo taken from the fire access road, looking northwest at the fence line separating the adjacent site from the subject parcel.

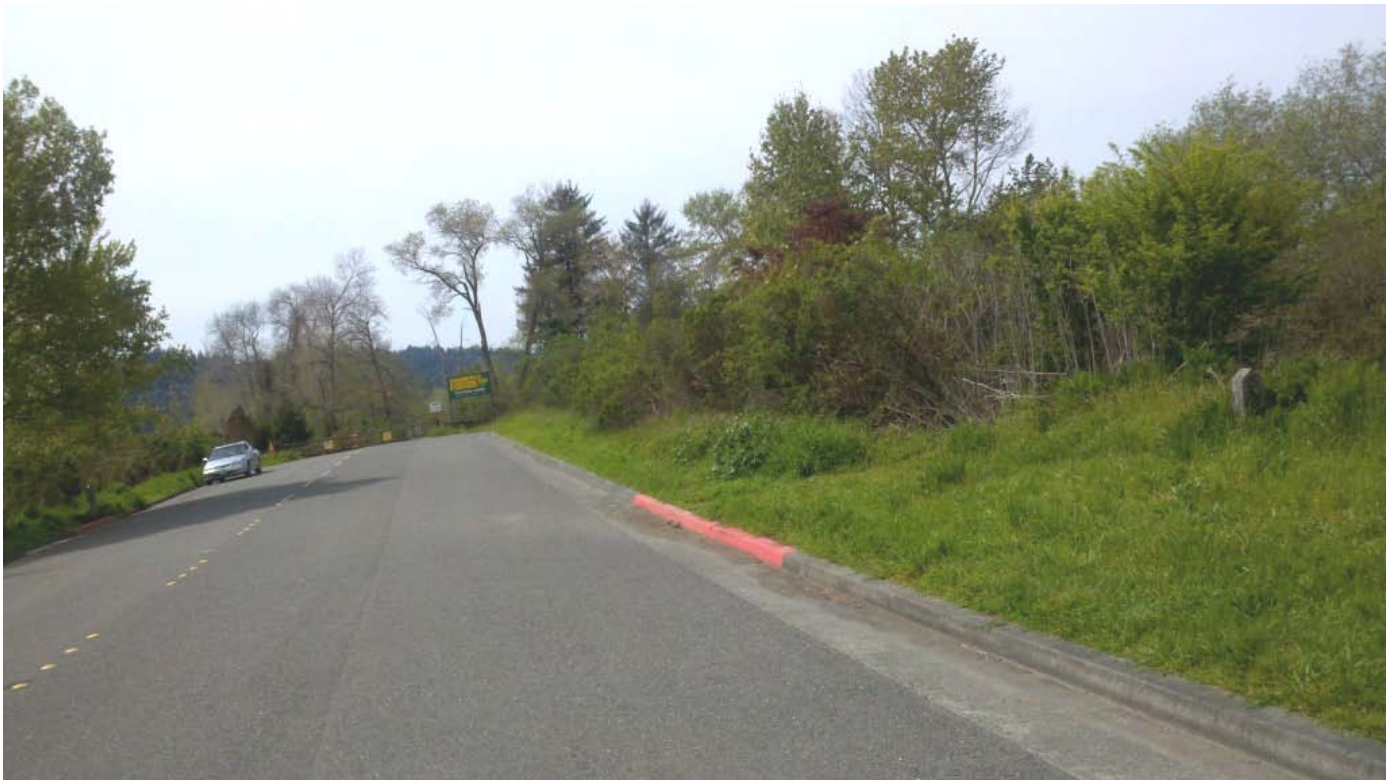
Photograph No. 4: Photo taken from Taylor Way looking at the west end of the City parcel (APN 312-161-018), and the western adjacent area. Taylor Way ends at the gate, into the former Granite Construction facility.

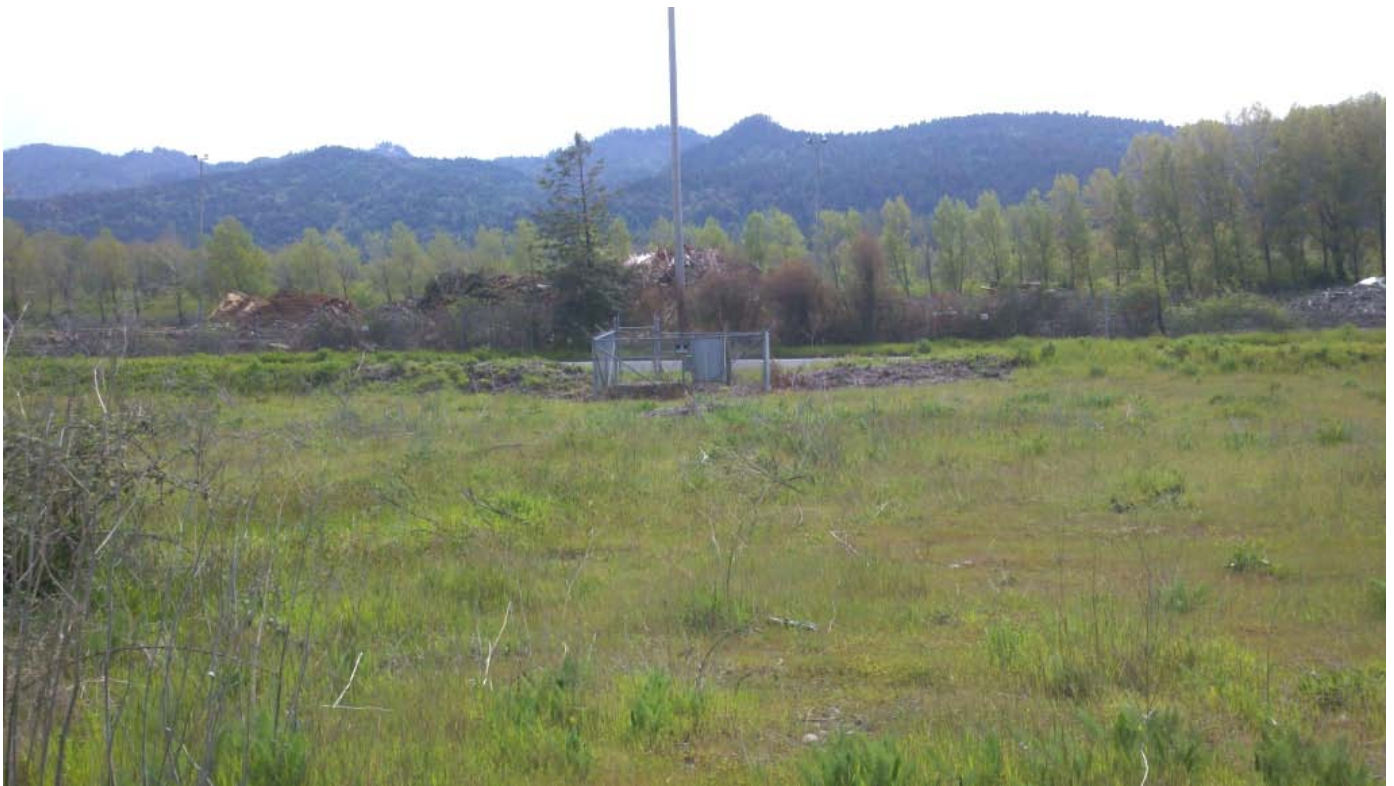
Photograph No. 6: Photo taken looking south at the City's Parcels (APN 312-161-015 and -018), and the pump station between the two, near Taylor Way.

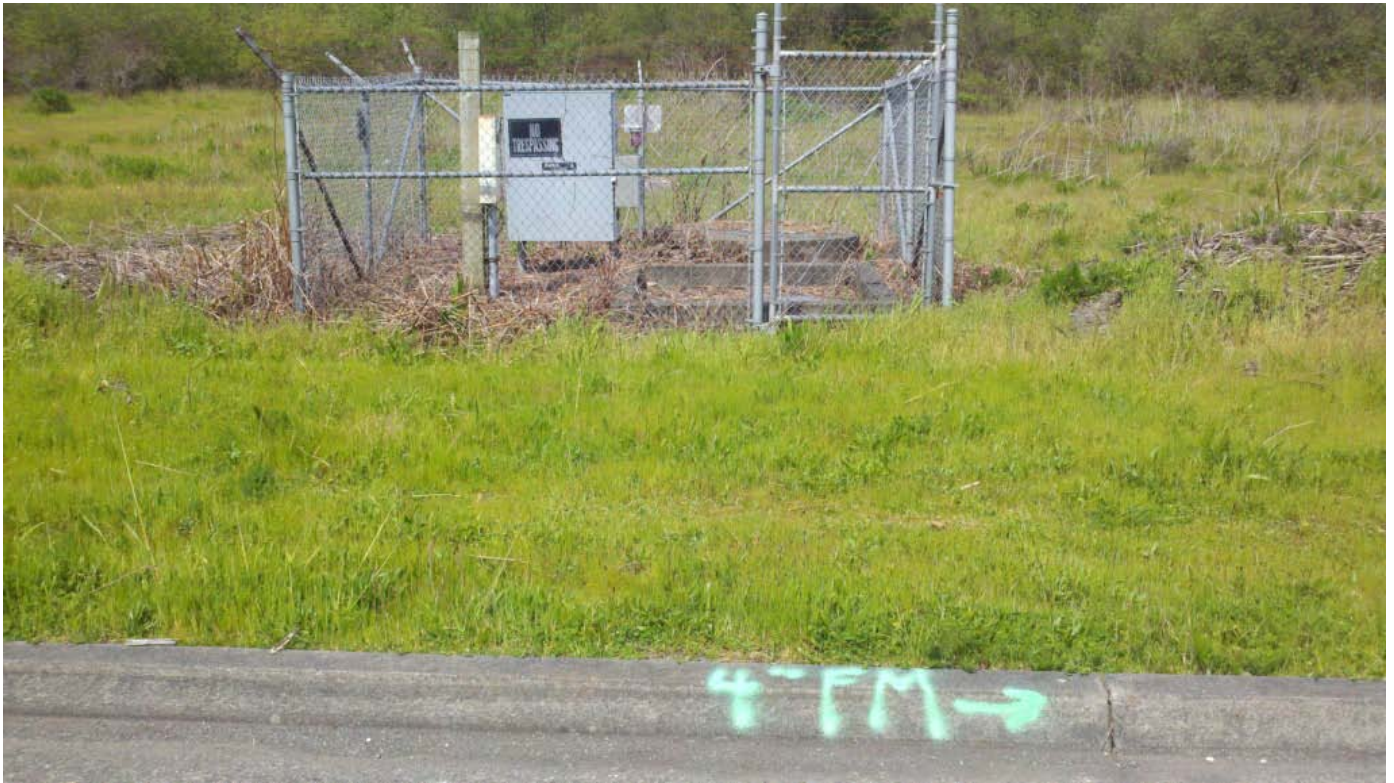
Photograph No. 7: Photo taken from Taylor Way looking north at the City pump station, which is between the two City parcels (APN 312-161-015 and -018). There is a 4-inch force main along Taylor Way, as well as other underground utilities.

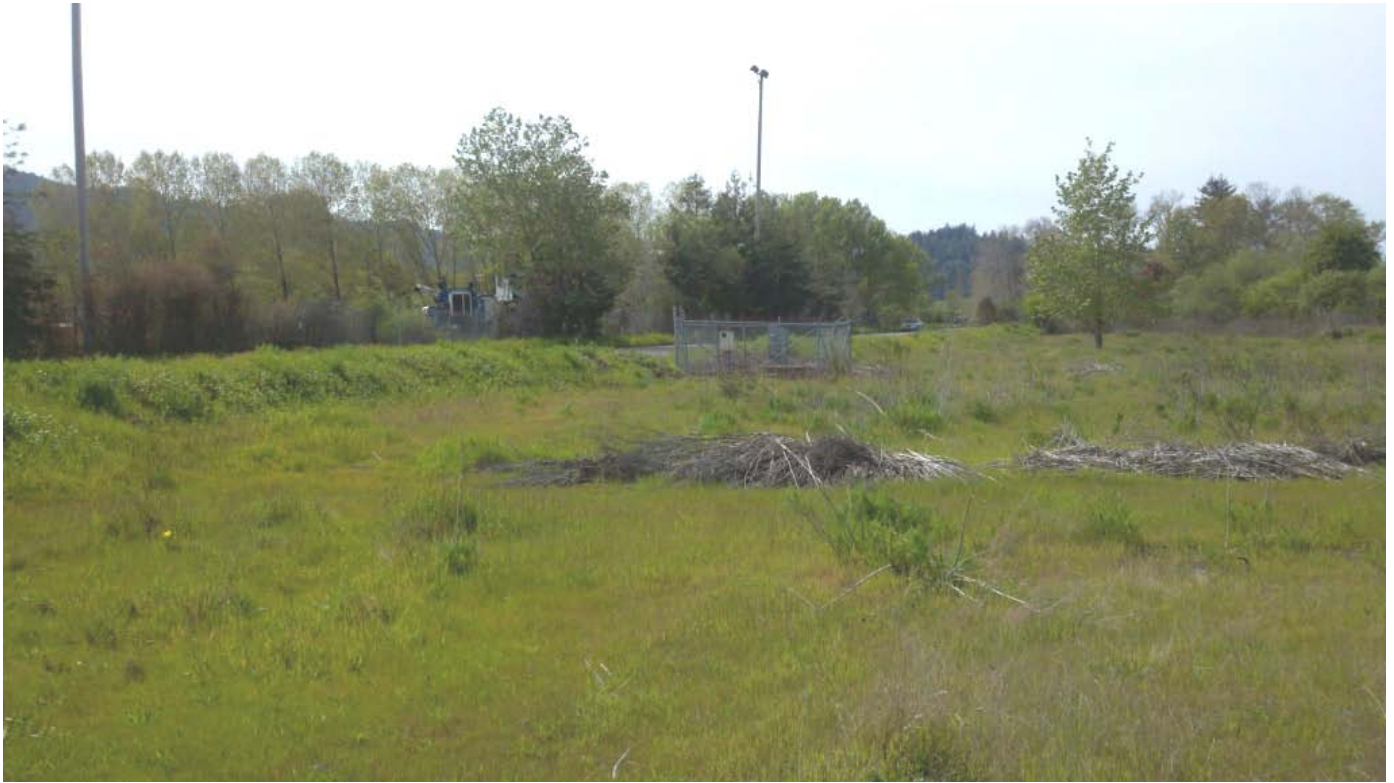
Photograph No. 8: Photo taken from the City-owned parcel (APN 312-161-015), looking southwest. Note the soil berm along the southern border of the parcel.

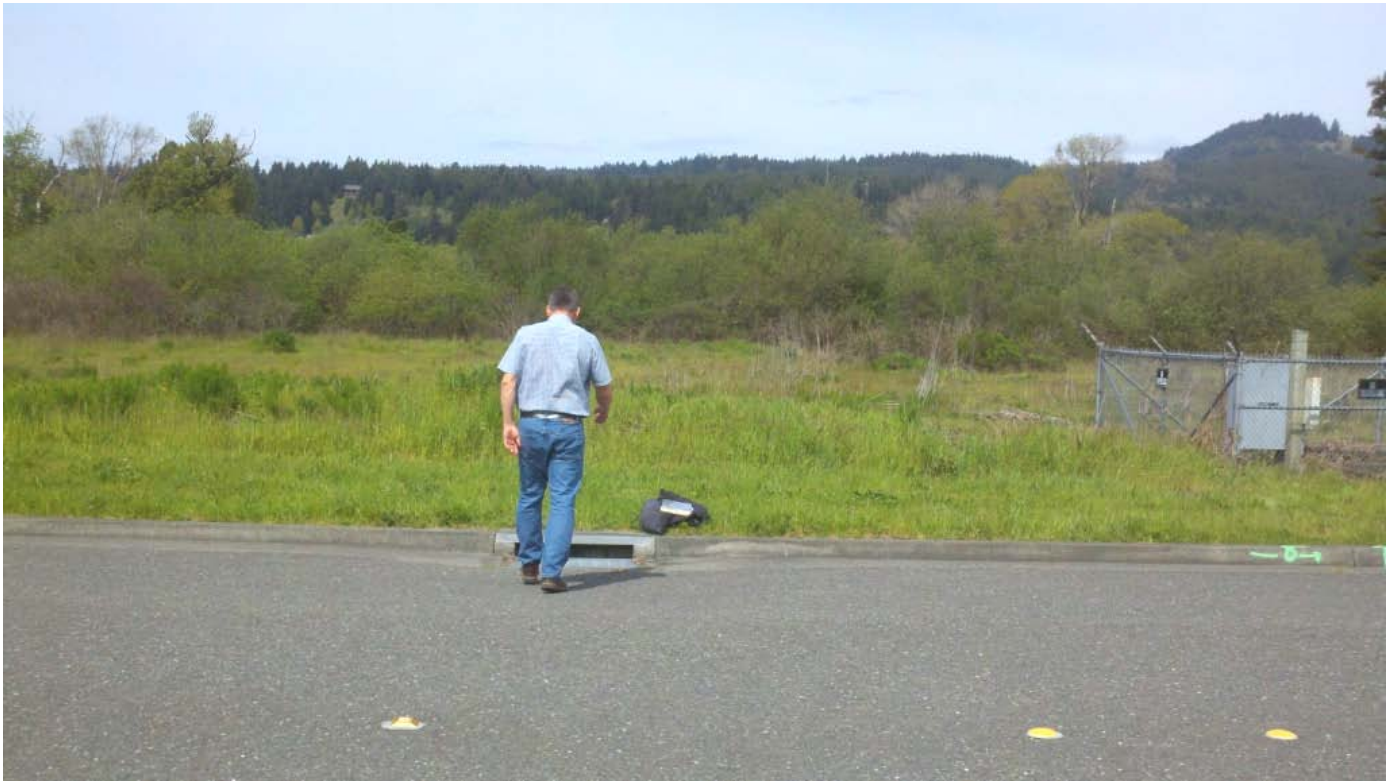
Photograph No. 9: Photo taken looking north at the storm drain drop inlet on Taylor Way. There is a storm drain that traverses between the two City parcels and discharges north into the creek.

SHN observed a municipally developed storm drain system for the business park, which is situated below Taylor Way and Monda Way. DIs are situated on each side of the intersection of Taylor Way and Monda Way, and a DI on the northern edge of the turn-around on Monda Way. Additionally, there is a 10-inch storm drain pipe below Monda Way that eventually discharges north to Powers Creek. SHN observed a couple of DIs on the western end of Taylor Way that empty into a 36-inch below grade storm drain system, which traverses northward across a City-owned parcel to Powers Creek (Appendix C).

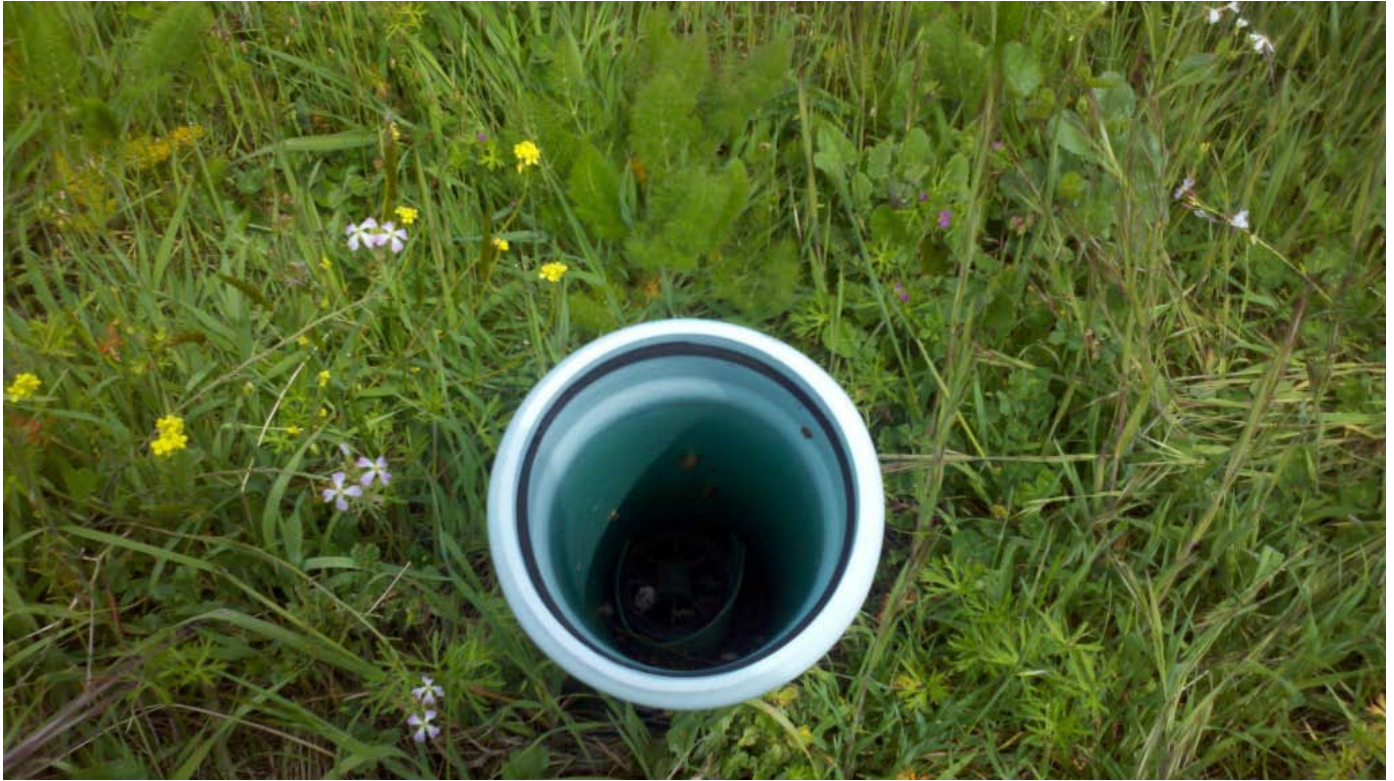
Photograph No. 13: Photo taken of a green pipe over a cleanout plug (APN 025-201-006).

North of the subject parcel is a City-owned parcel that contains the City's dumping area. East of the parcel is Monda Way, which has below grade water, sewer, and storm drain piping. A cleanout plug was observed near the curb on Monda Way, and it was protected with a Polyvinyl Chloride (PVC) riser pipe.

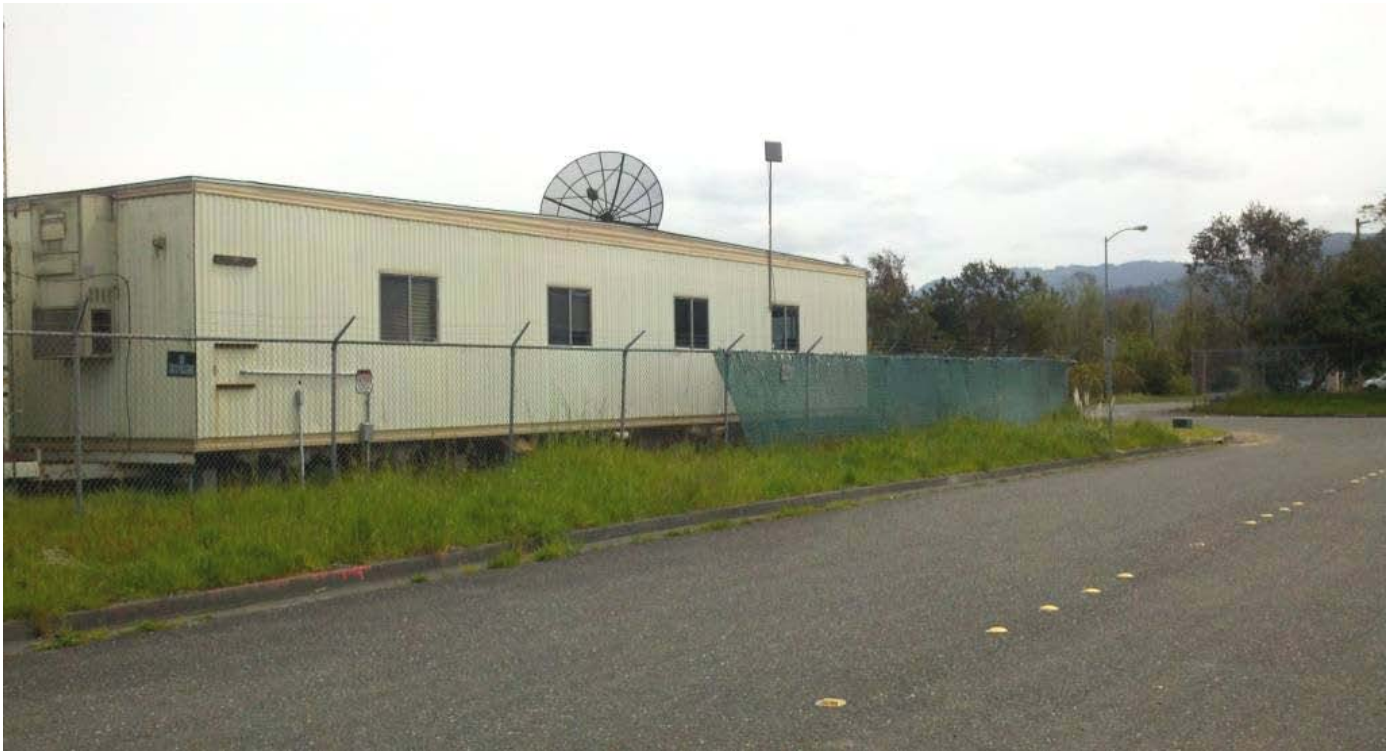
Photograph No. 14: Photo taken looking at the utility easement (APN 025-201-001) and at the adjacent parcel (APN 025-201-018), north of the City corporation yard. The parcel is a contractor's yard, with a building and partially overgrown yard area. Beyond and north of the building is the sewer pump station (APN 025-201-001).

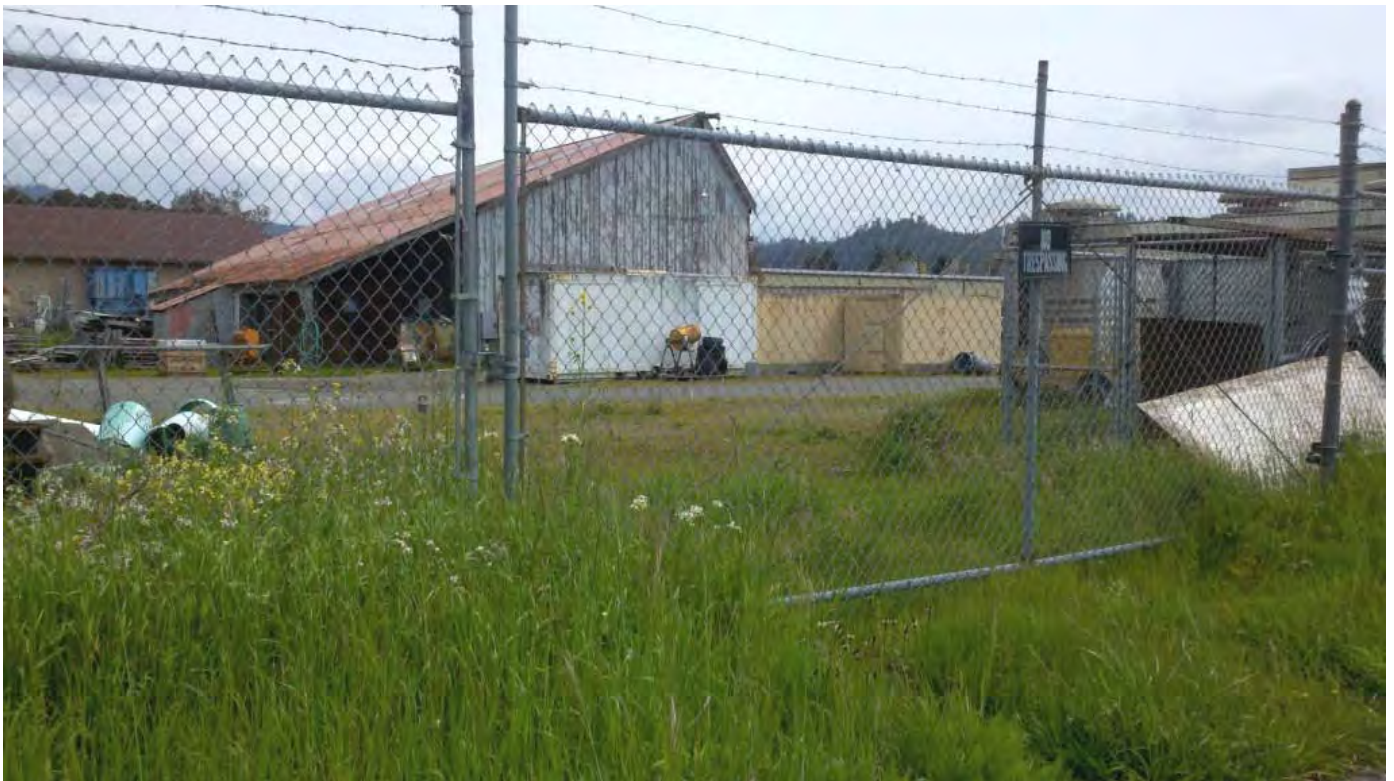
Photograph No. 15: Photo taken from Monda Way looking at the western side of the City corporation yard (APN 025-201-019 and 025-201-009), which has the double wide office trailer. The corporation yard is surrounded by chain link fencing, and on the western side, there is curb and gutter (with a grass buffer strip between).

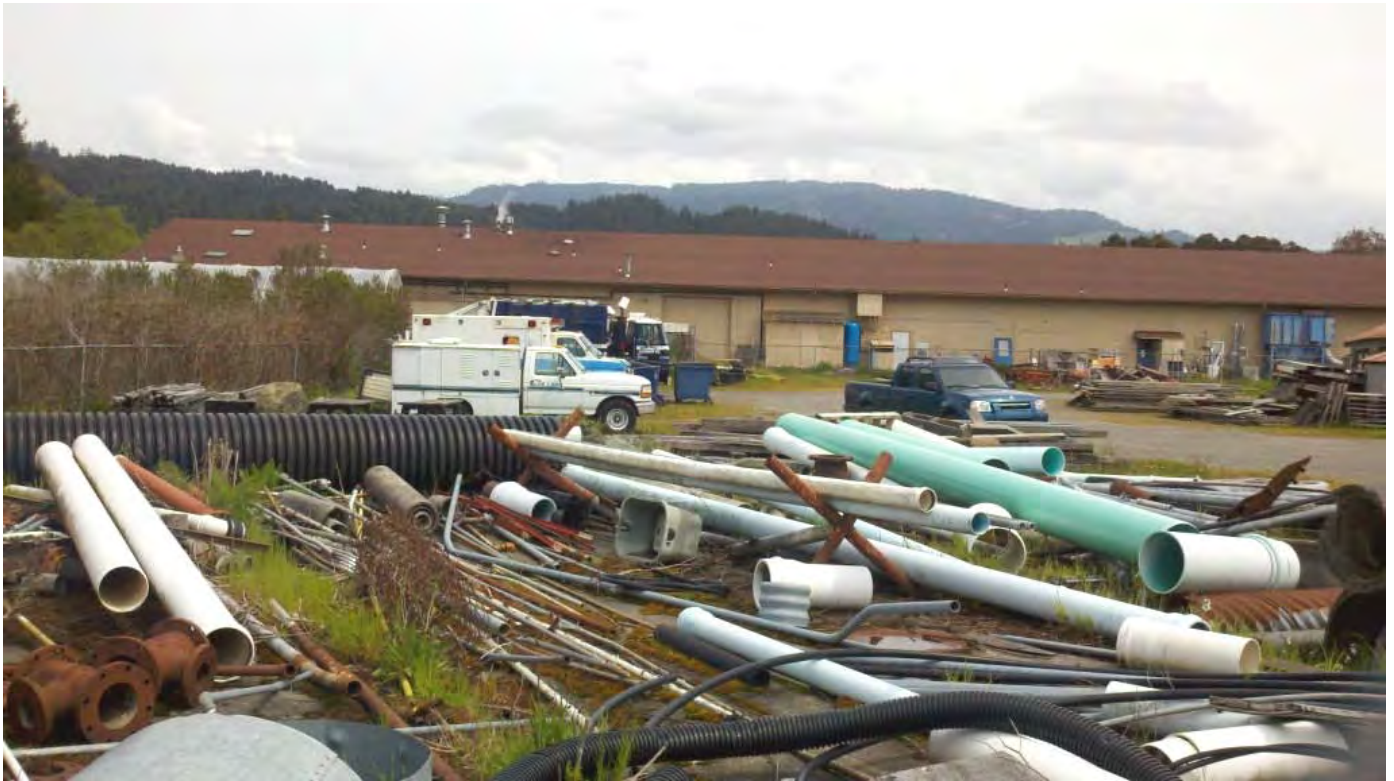
Photograph No. 17: Photo taken looking at the northern side of the City corporation yard (APN 025-201-019), and the outside material storage area.

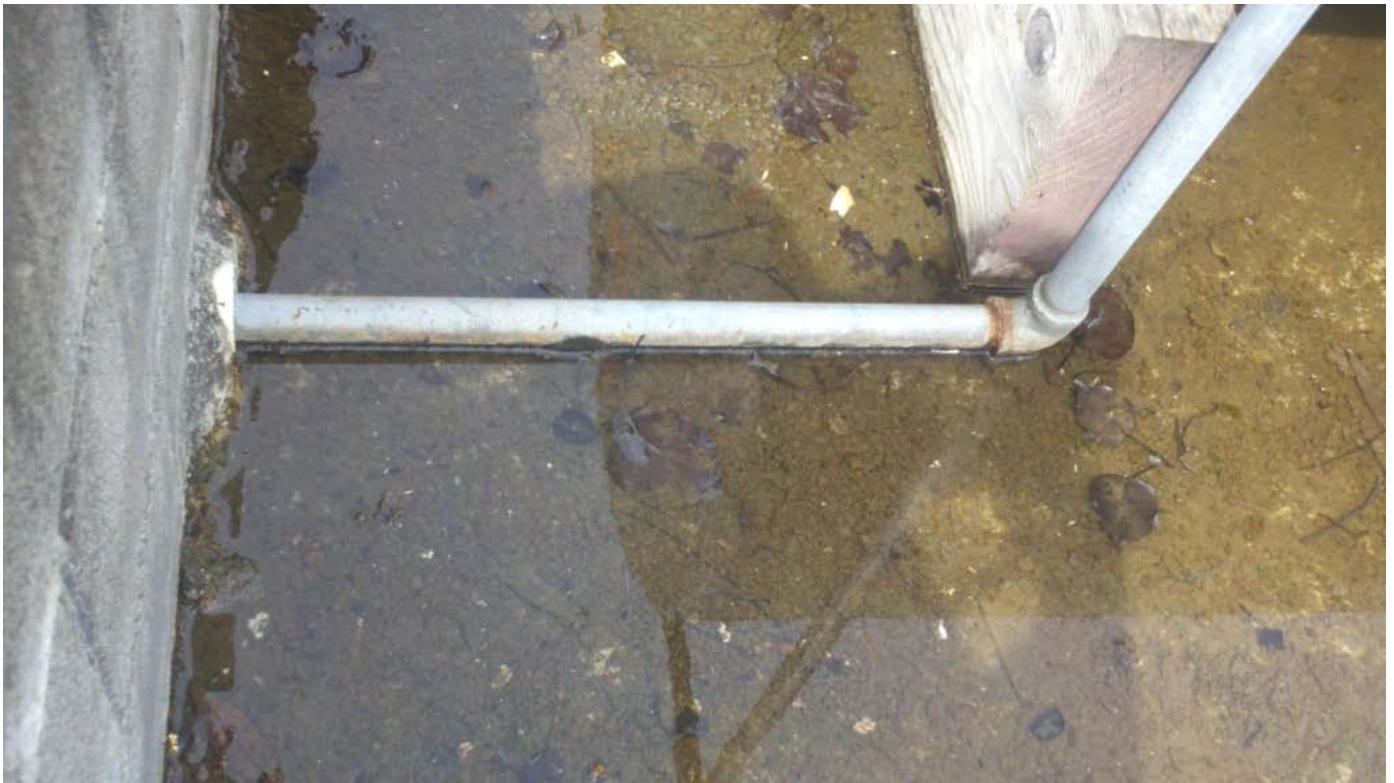
Photograph No. 30: Photo taken of the aboveground piping to the dispensers, within a second outer pipe, as it passes through the concrete to the dispenser.

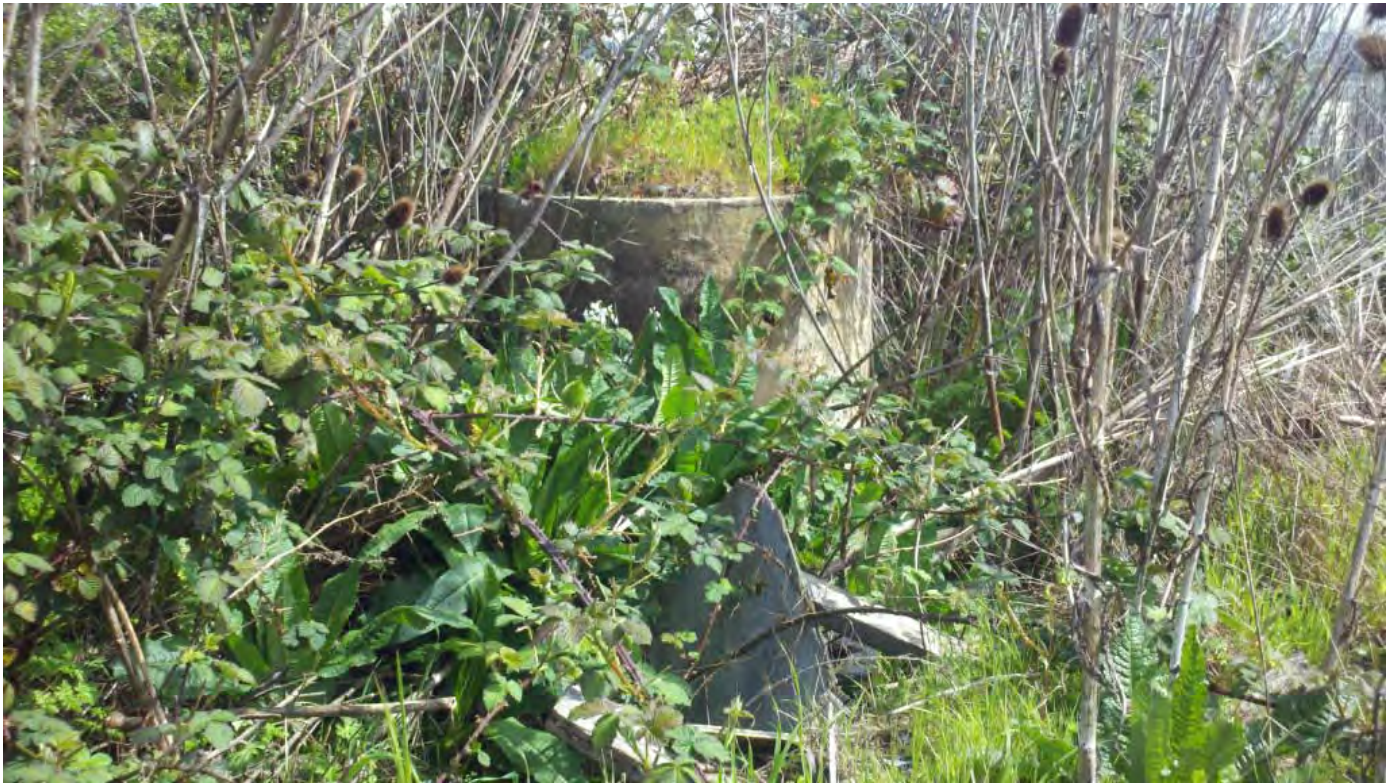
Photograph No. 35: Photo taken of fill material on City parcel APN 025-201-002.

Much of these parcels (APNs 025-201-002, 025-201-006, 312-161-015, and 312-161-018) footprints historically consisted of a log pond for mill operations, which was later filled. Subsurface investigation logs indicate approximately 9 feet of fill material within the filled log pond described as gravel, sand, wood debris, bark, and burner cinders (NGS, 1981).

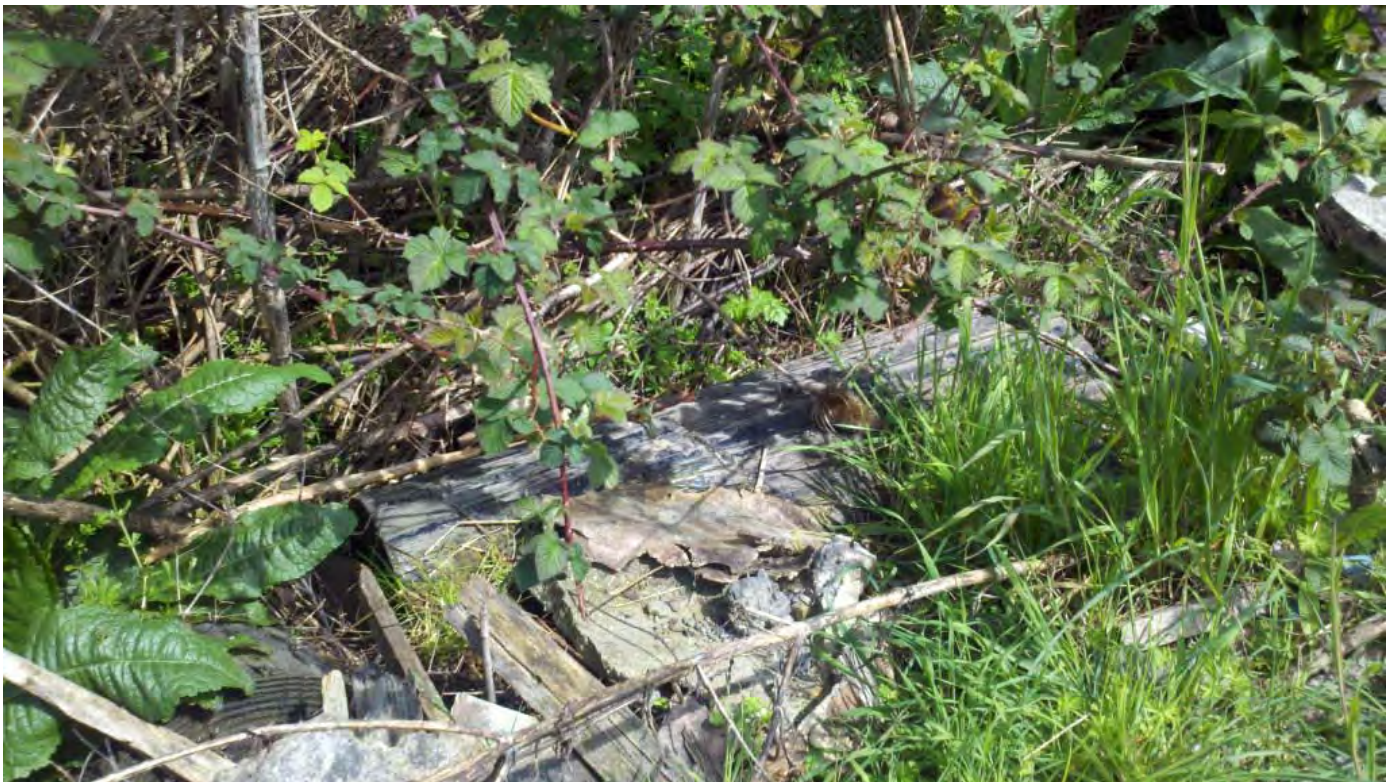
Photograph No. 36: Photo taken of fill material on City parcel APN 025-201-002.

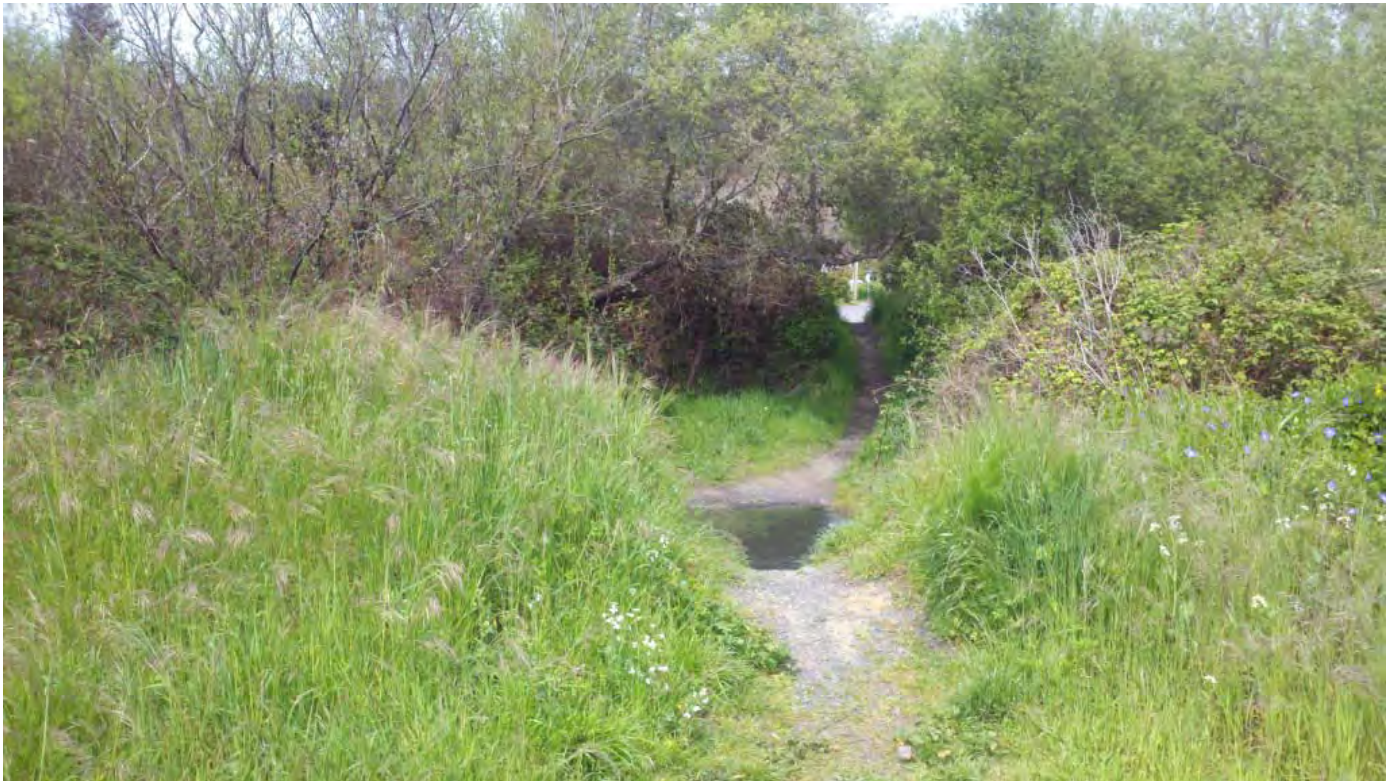
Photograph No. 37: Photo taken from the fire access road looking south at Monda Way. This photo shows the utility easement from Monda Way to the pump station.

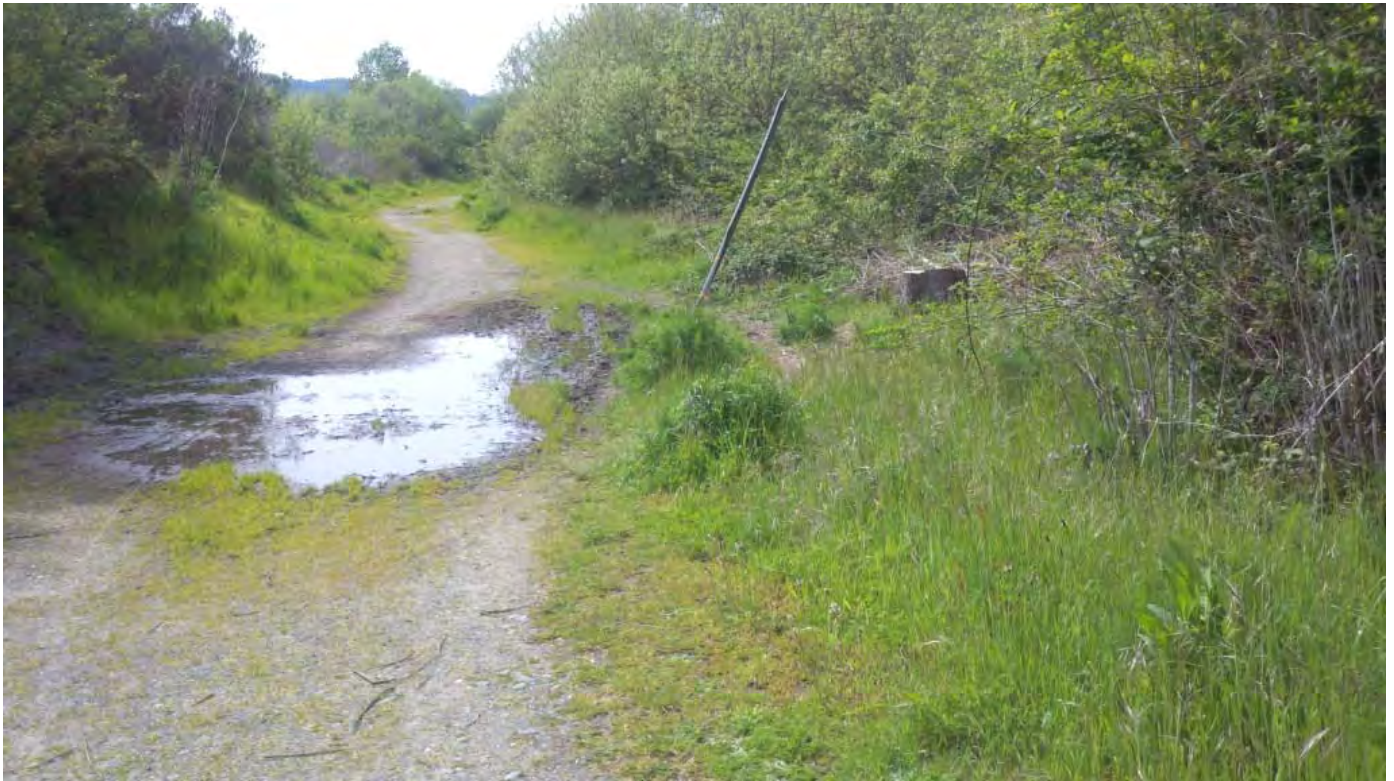
Photograph No. 40: Photo showing the City pump station on the right, and the contractor's yard on the left (APN 025-201-018).

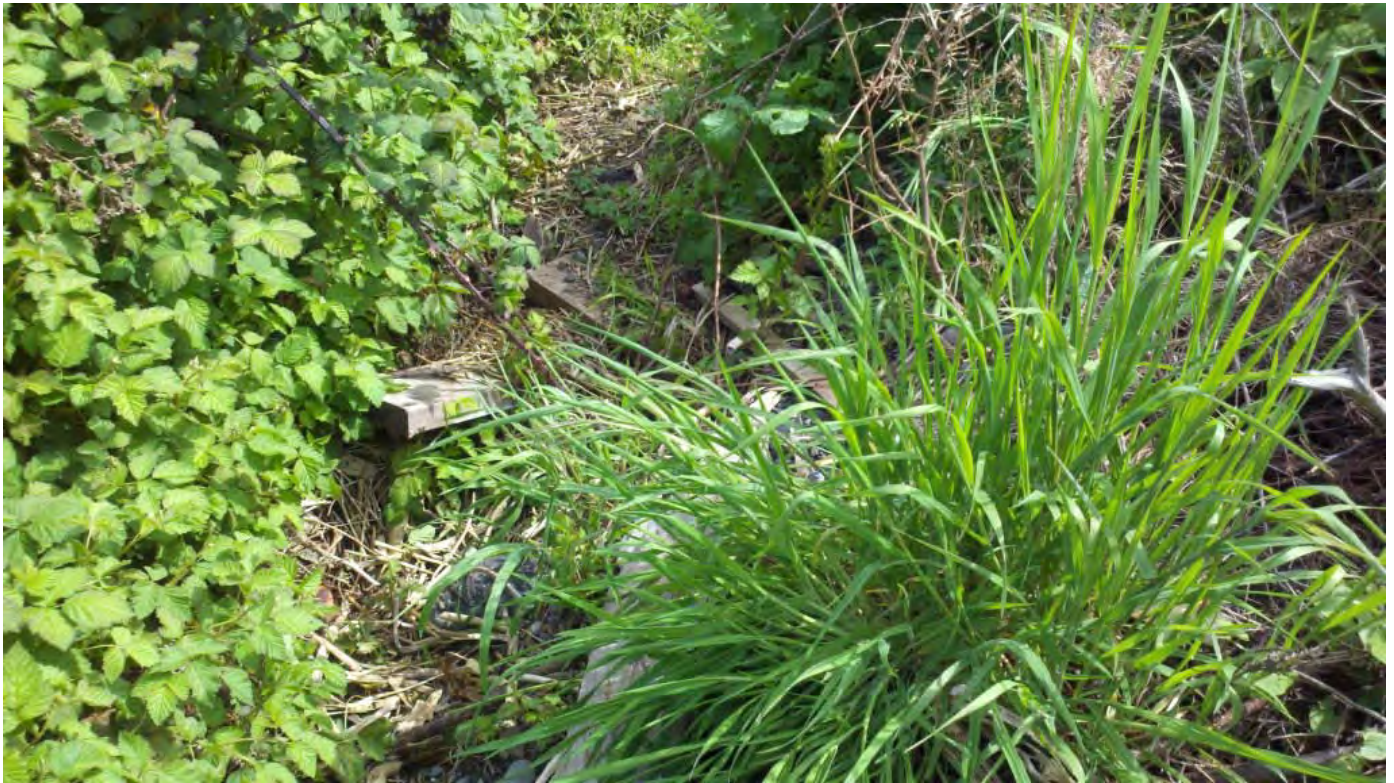
Photograph No. 43: Photo taken of some of the debris (wood, soil, asphalt, and green waste) that is located within the City's dumping area.

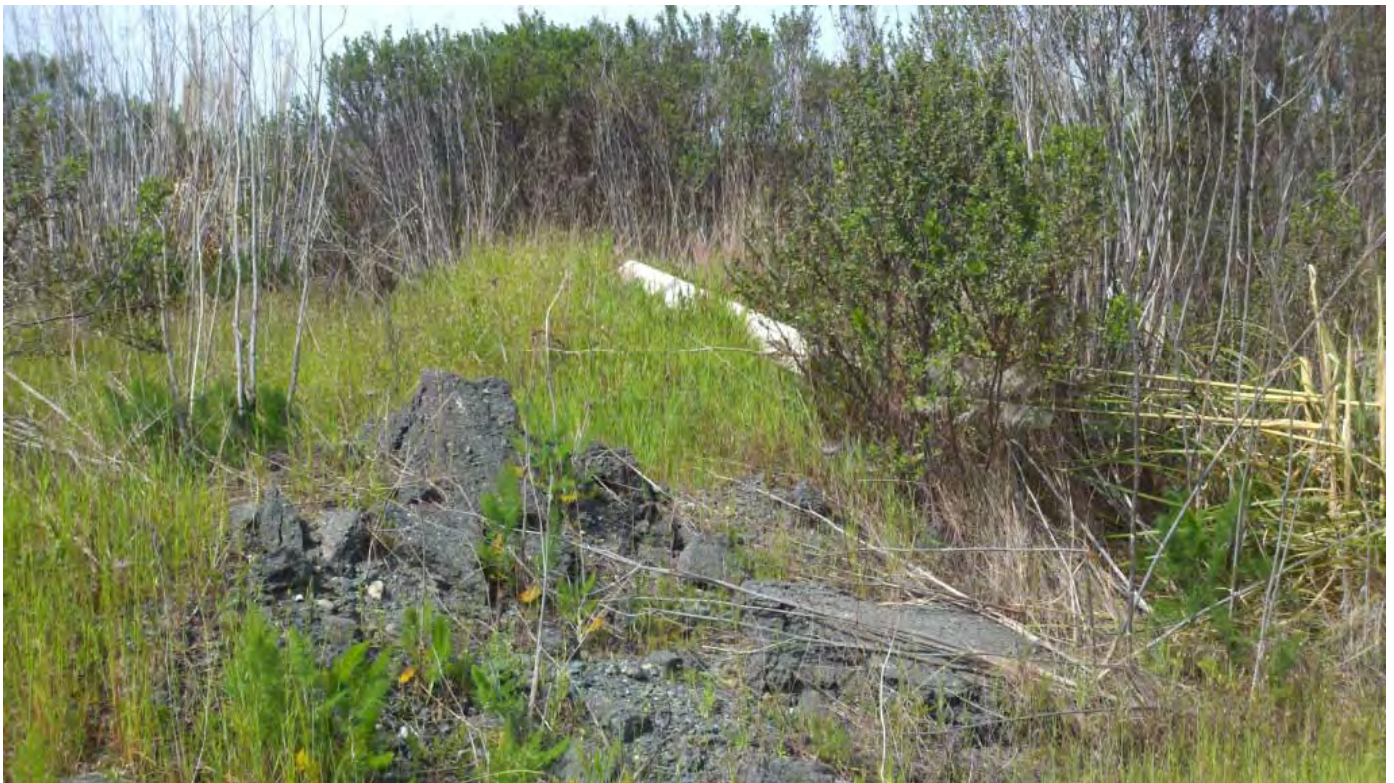
Photograph No. 44: Photo taken of fill material on City parcel APN 025-201-002.

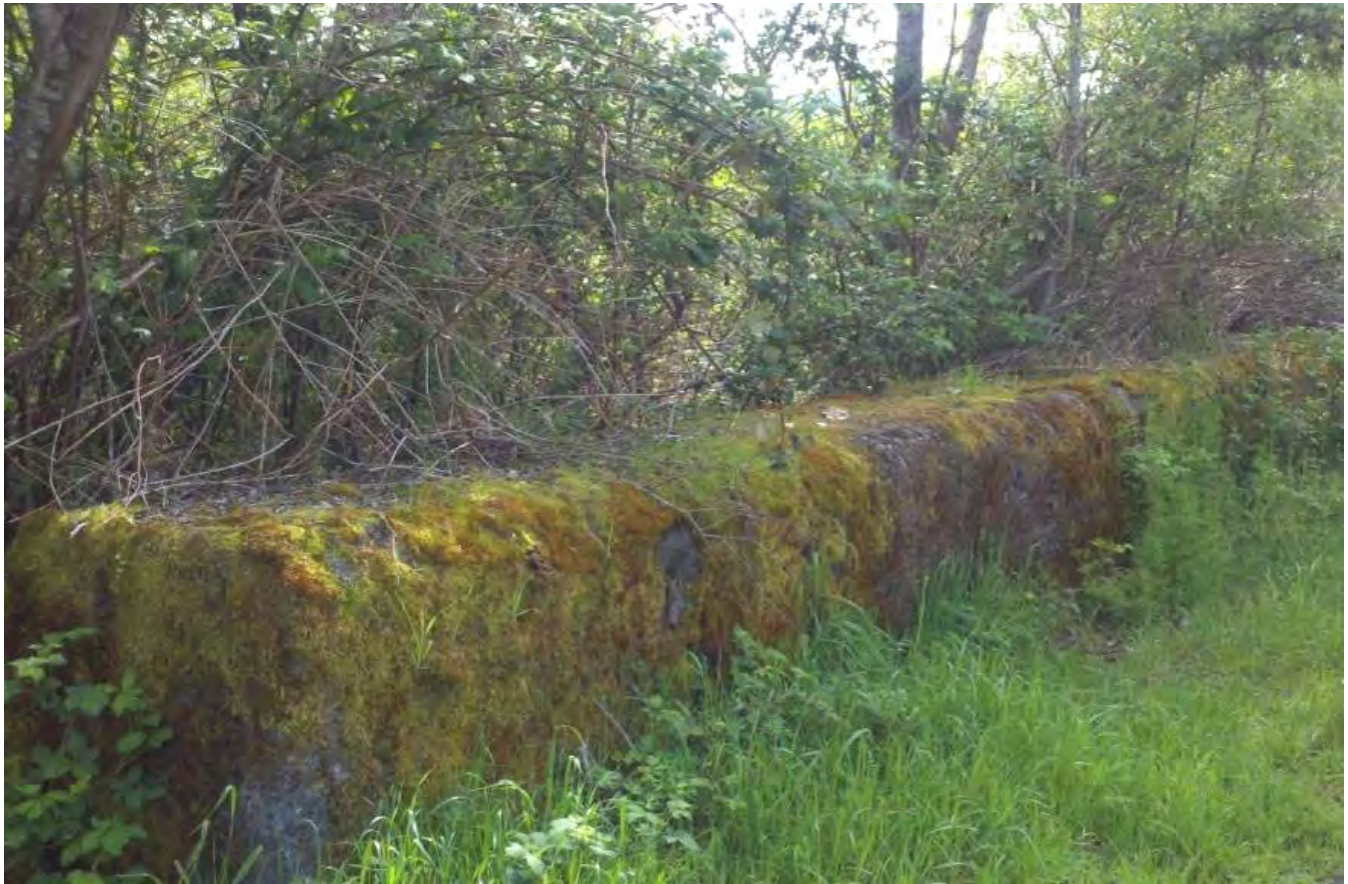
Photograph No. 45: Photo taken from the fire road looking south at the former log dump concrete deck. To the south is the former log pond (APN 312-161-015), which has been filled in.

North of Taylor Way is a City-owned parcel (APN 312-161-015), which is vegetated with grasses and brush. During the site walk, we observed the former concrete log dump structure, which is situated on the northern side of the parcel. Based upon historic maps much of this parcel has a filled in log pond.
