Phase I Environmental Site Assessment

Blue Lake Business Park

Blue Lake, Humboldt County, California

June 2011
011003.401

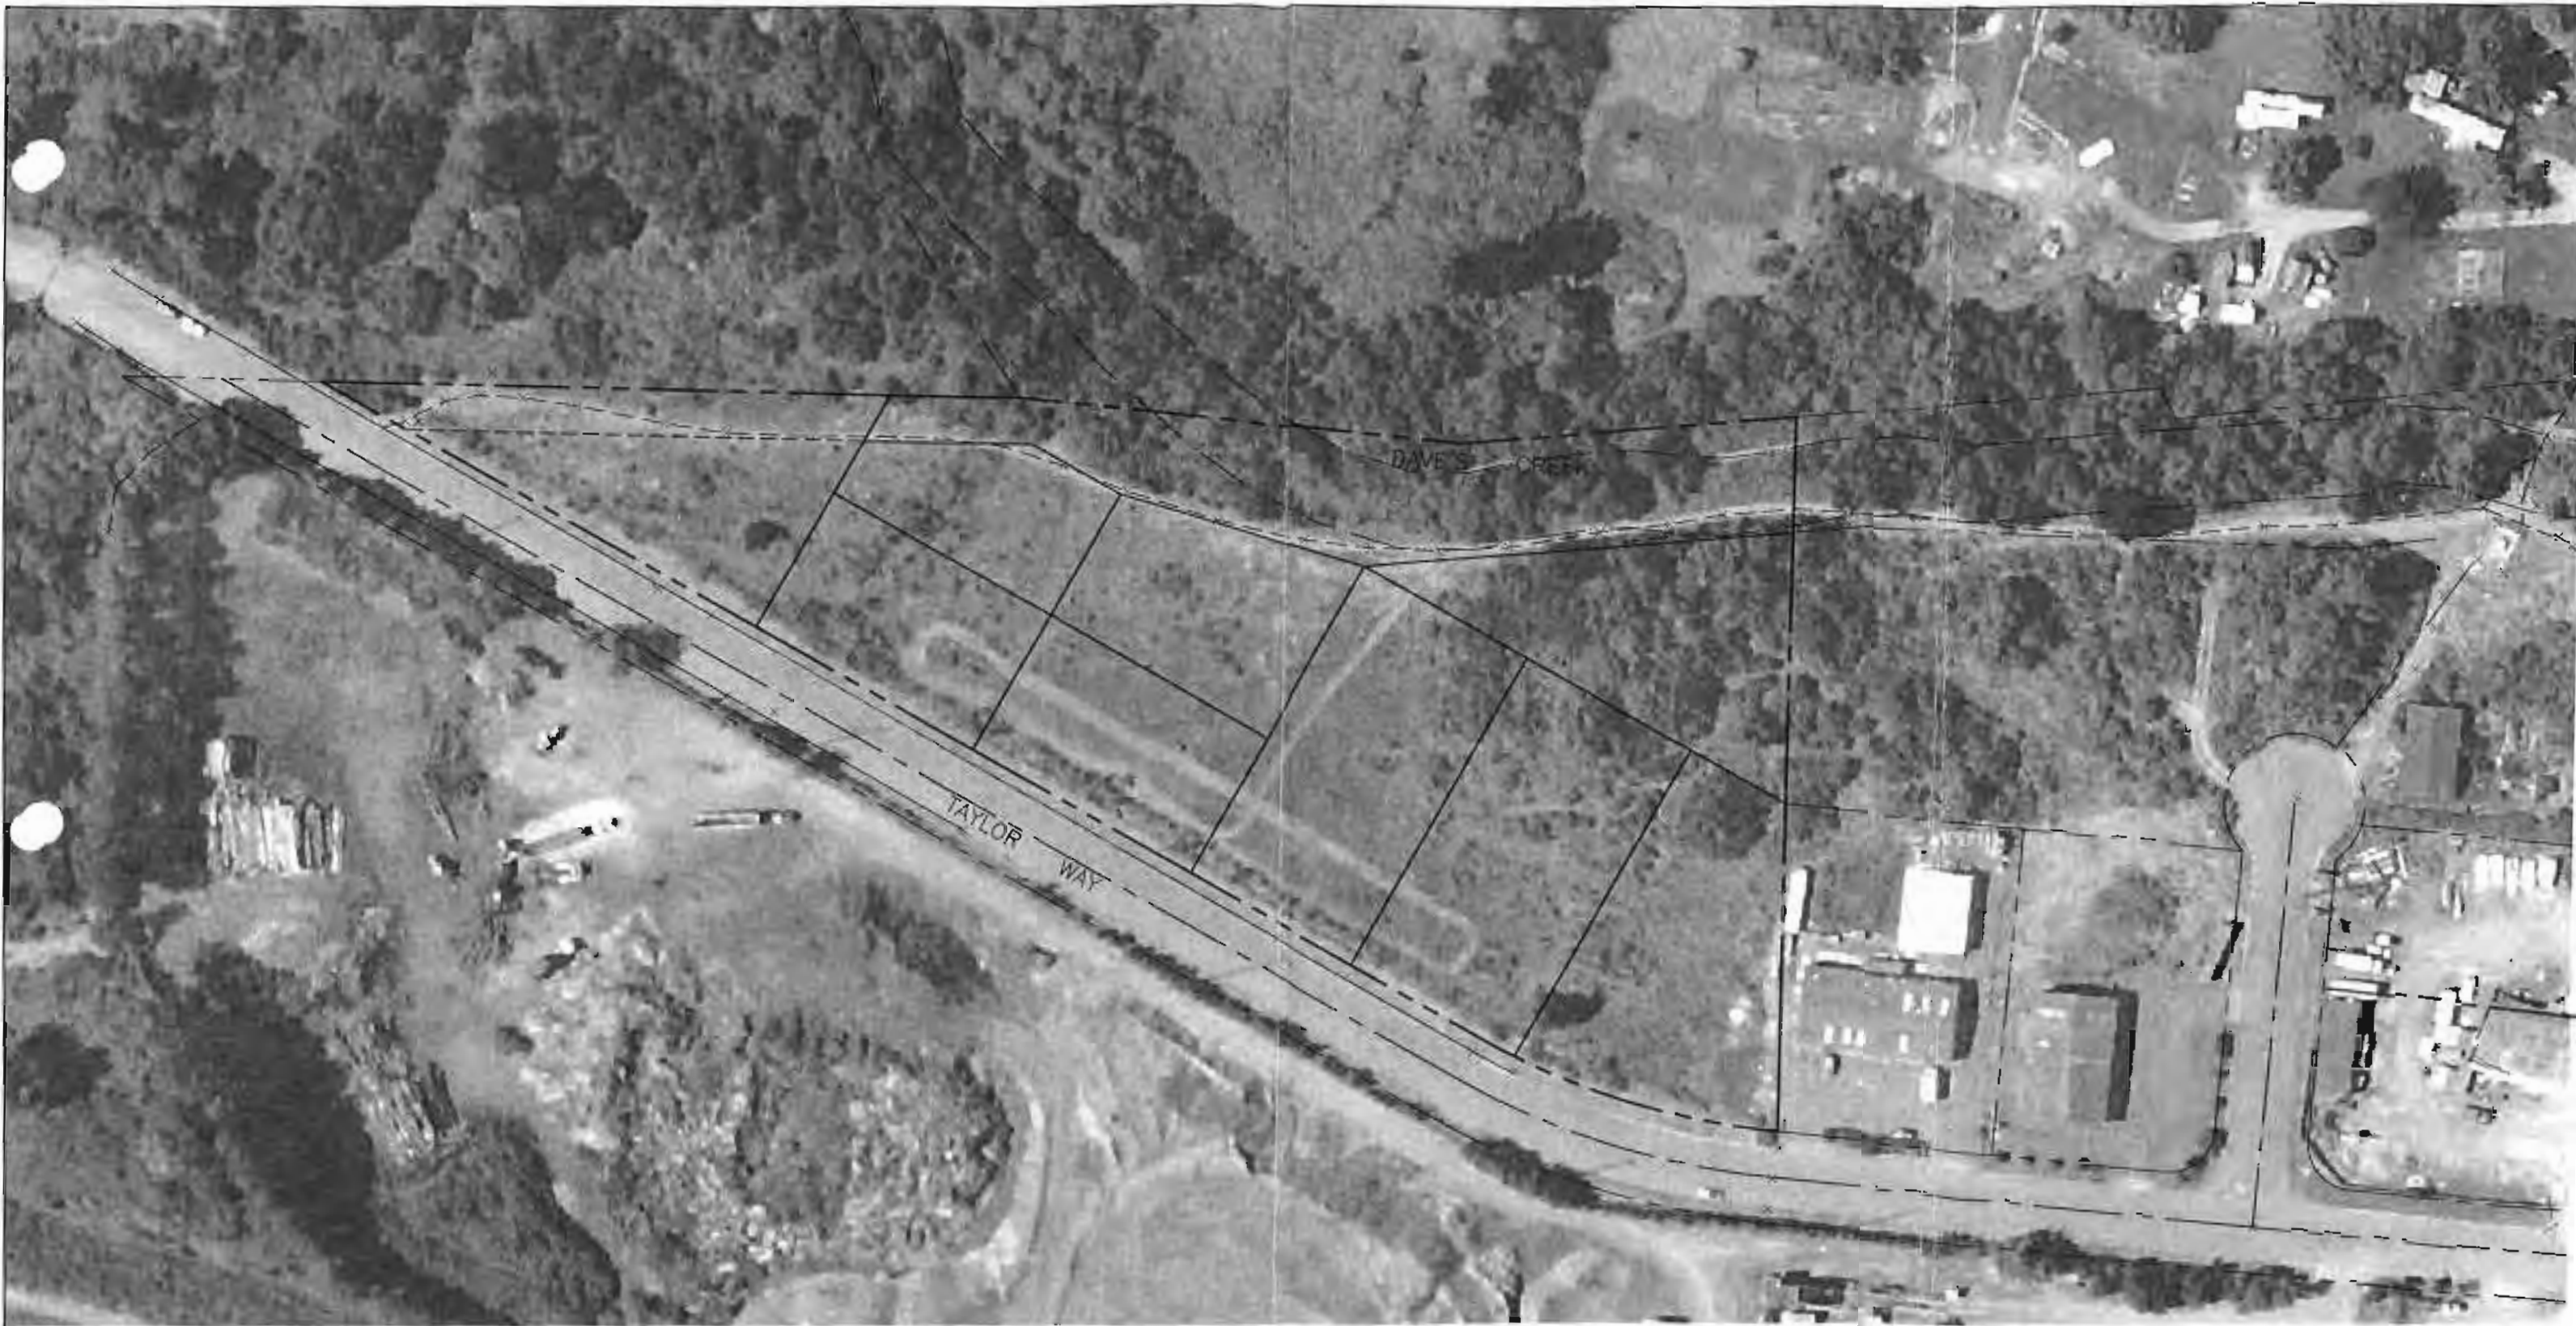
Blue Lake Business Park Phase II
 APNs 312-161-15 & 18

PROPERTY OWNER/SUBDIVIDER:
 CITY OF BLUE LAKE
 P.O. BOX 458
 BLUE LAKE, CA 95525
 (707) 668-5655
 General Plan/Zoning: ML (Light-Industrial)
 Present Use: Vacant
 The purpose of this subdivision is to create individual lots for lease and/or sale for future industrial development.
 JANUARY 2, 1996 Robert Brown
